**ATTACHMENT 2
IMAGES TAKEN BY PETER LOVELL ON 24 JULY 2014**

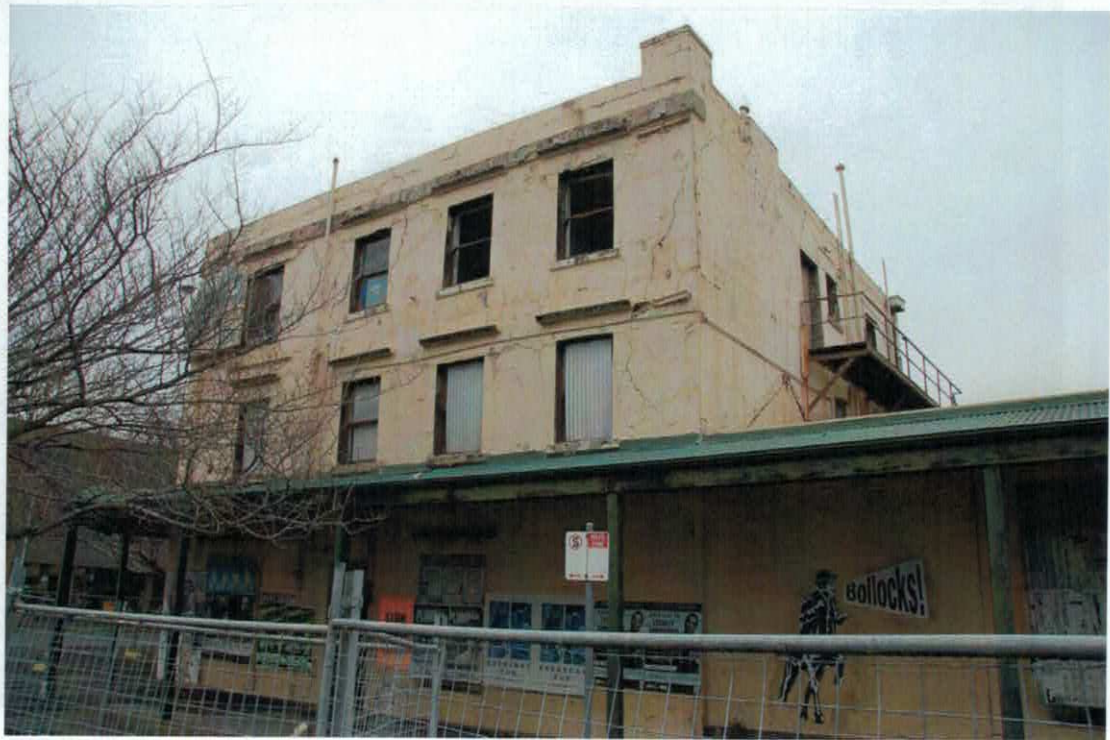
Figure 1 The Ann Street elevation of the Oriental Hotel

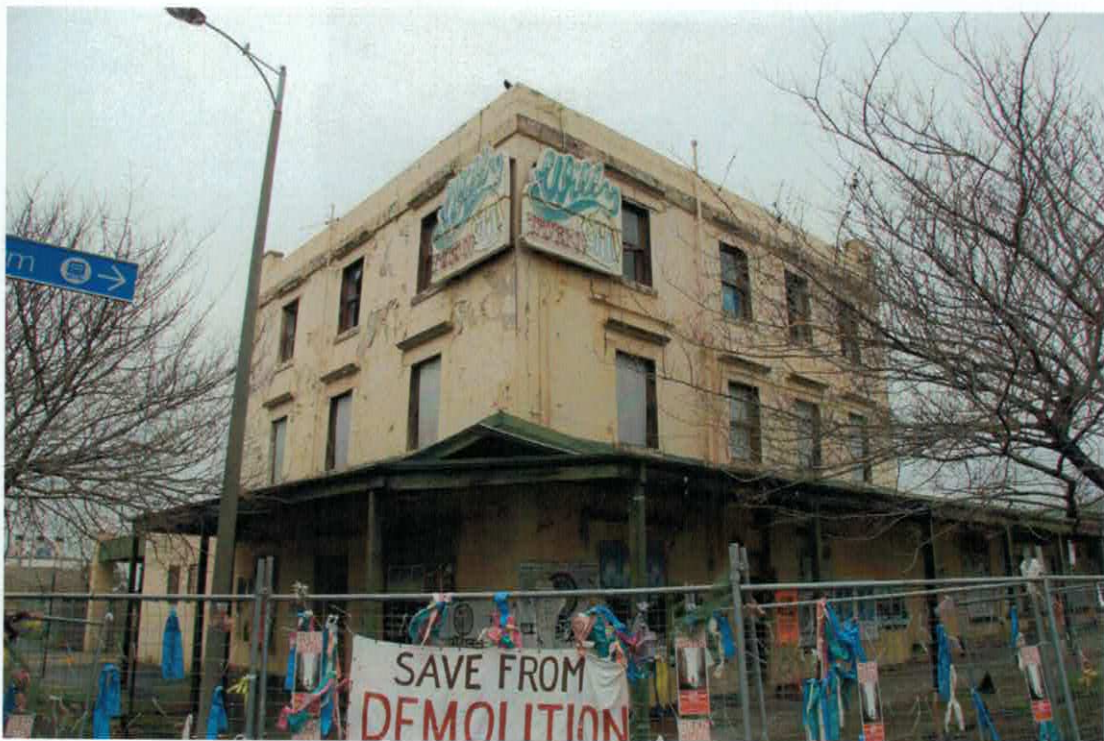
Figure 2 The Ann Street and Nelson Place elevations of the Oriental Hotel

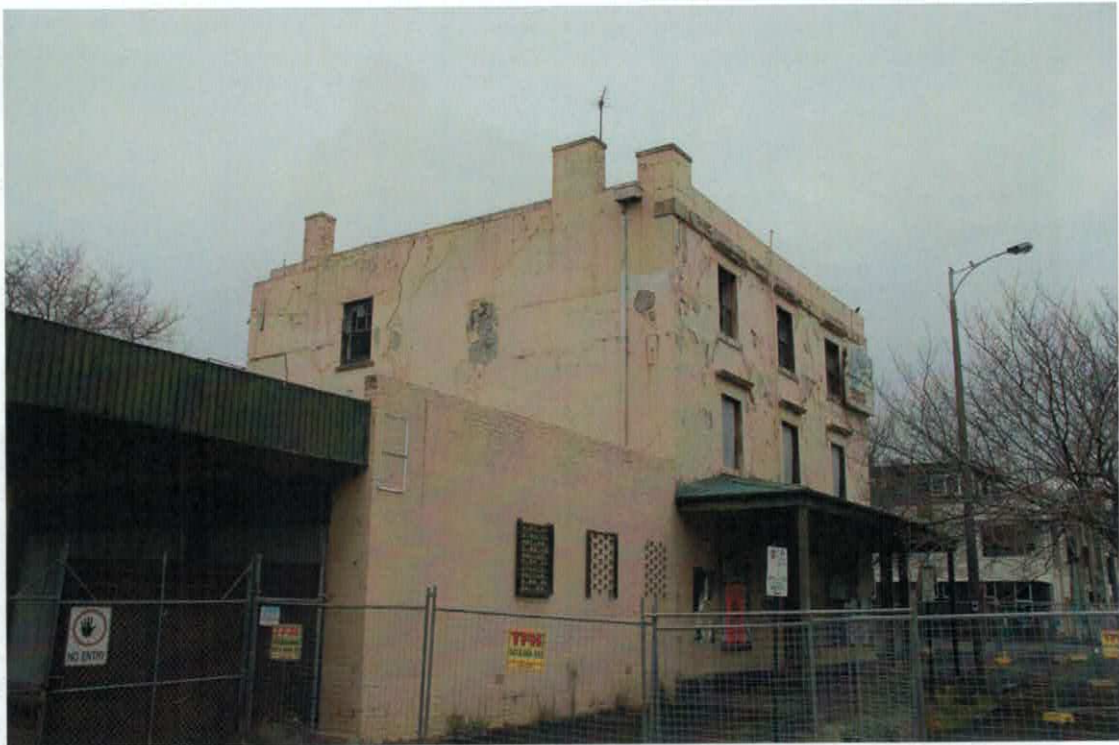
Figure 3 View of the hotel from Nelson Place

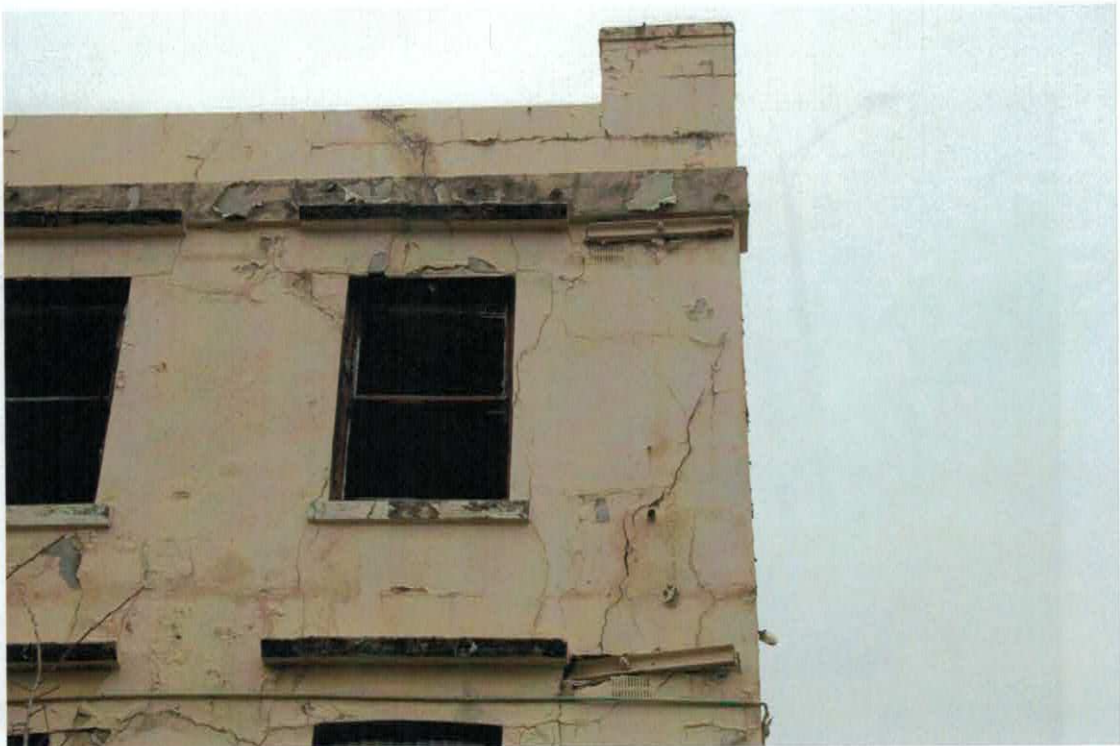
Figure 4 Detail of an upper level window

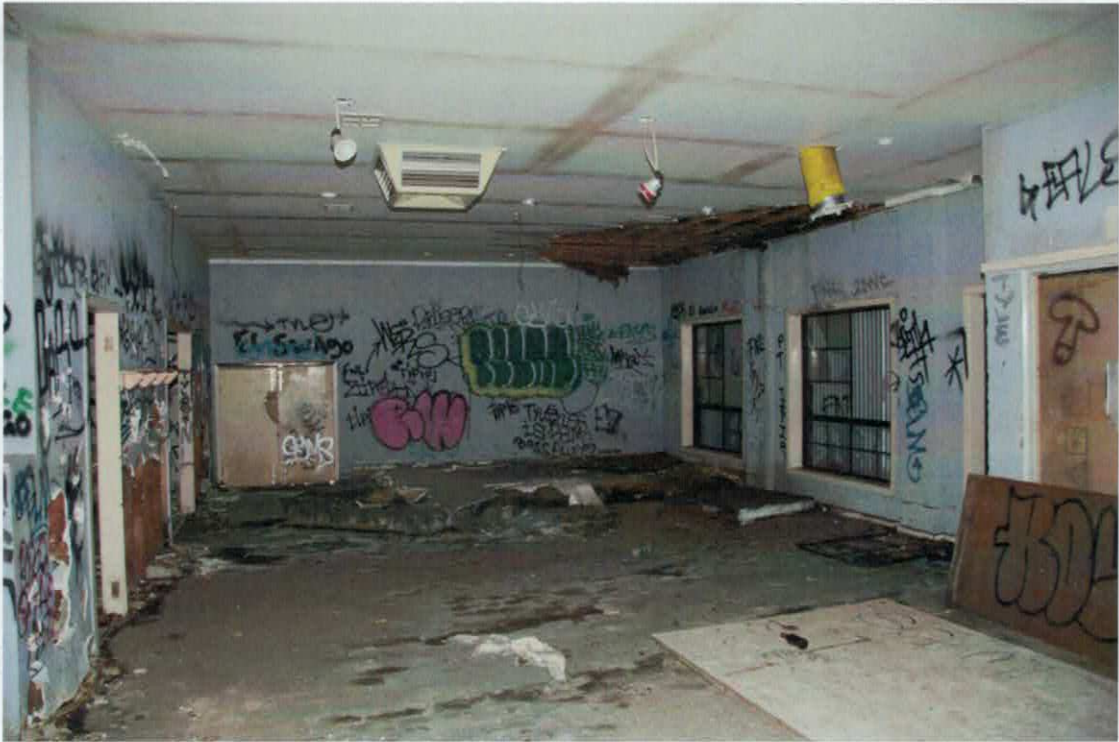
Figure 5 The single storey wing to Ann Street. The physical evidence indicates that the roof framing is of recent origins and that the Ann Street wall is constructed of modern brickwork.

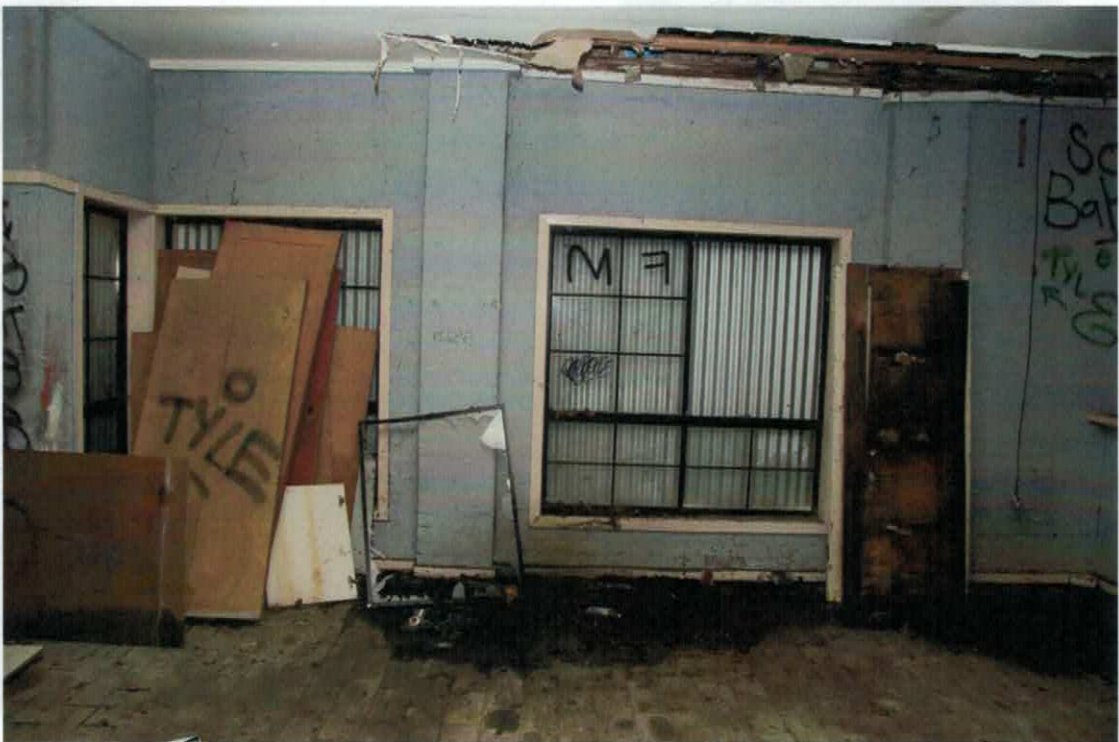
Figure 6 Detail of the Ann Street wall in the single storey wing

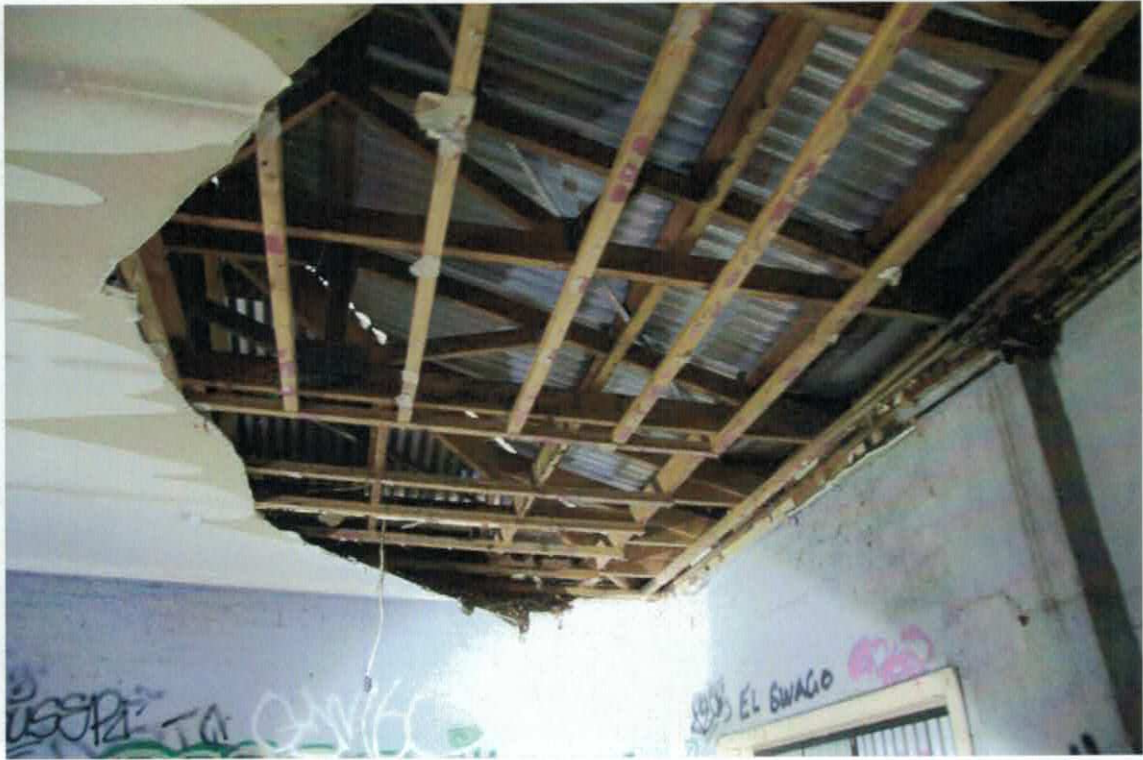
Figure 7 The roof framing to the Ann Street wing

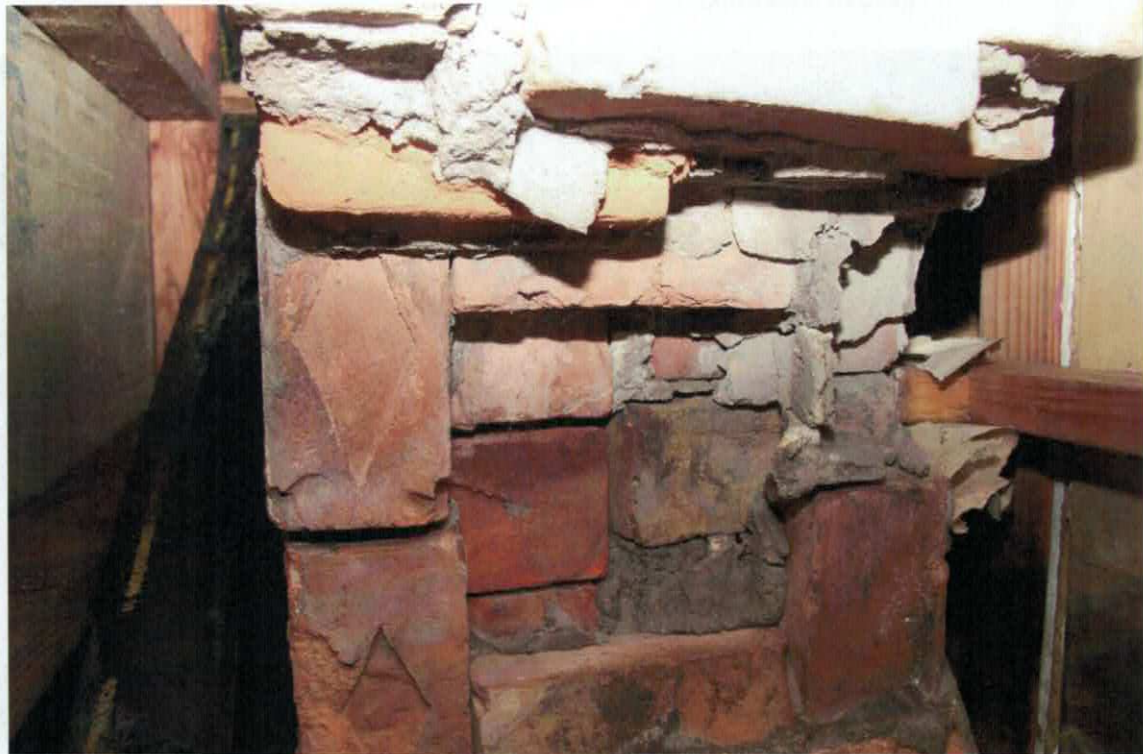
Figure 8 The walls are typically of solid brickwork. A single brick measured at 8" x 3 5/8th" x 2 1/2 inches. A diamond frog occurs in some bricks. The bricks are as would be expected for the date of construction.

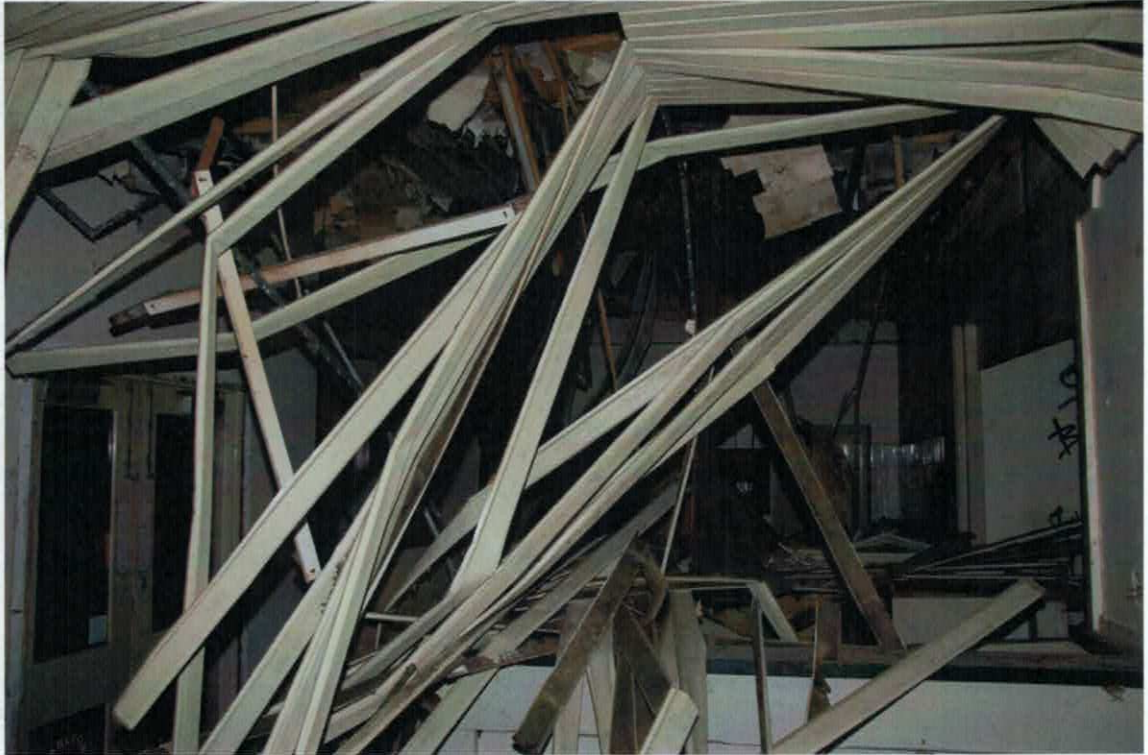
Figure 9 The partially collapsed ceiling and floor structure in the Nelson Place corner bar.

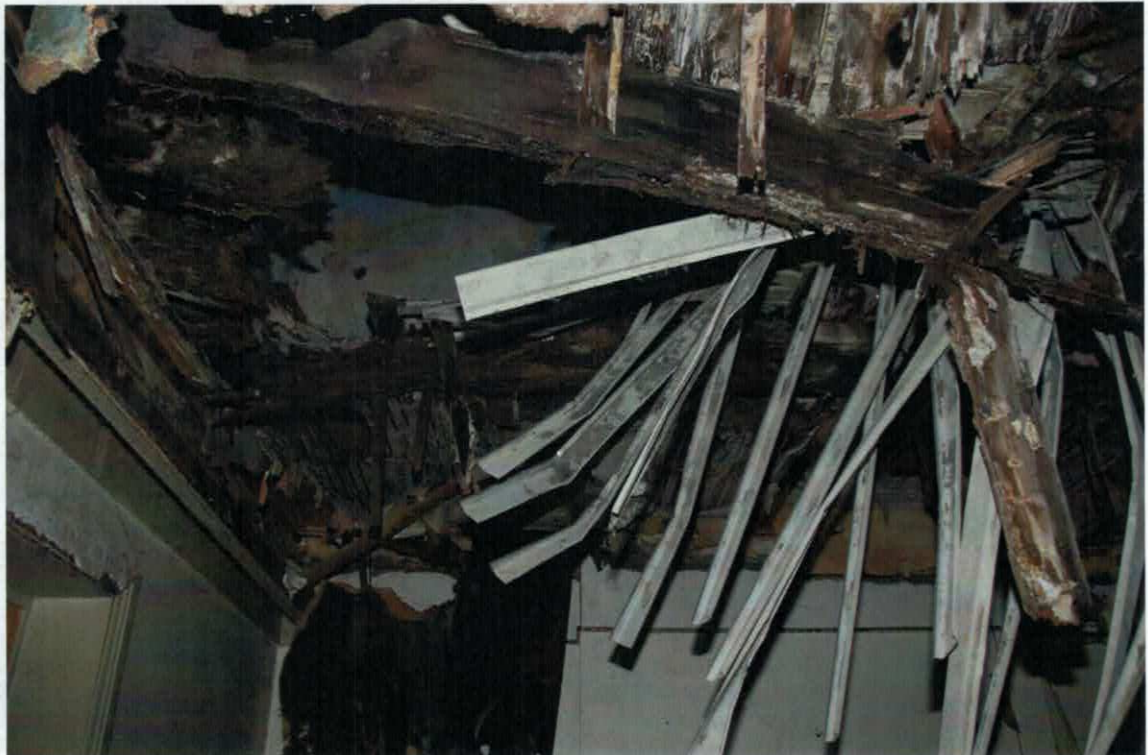
Figure 10 The partially collapsed ceiling and floor structure in the Nelson Place corner bar.

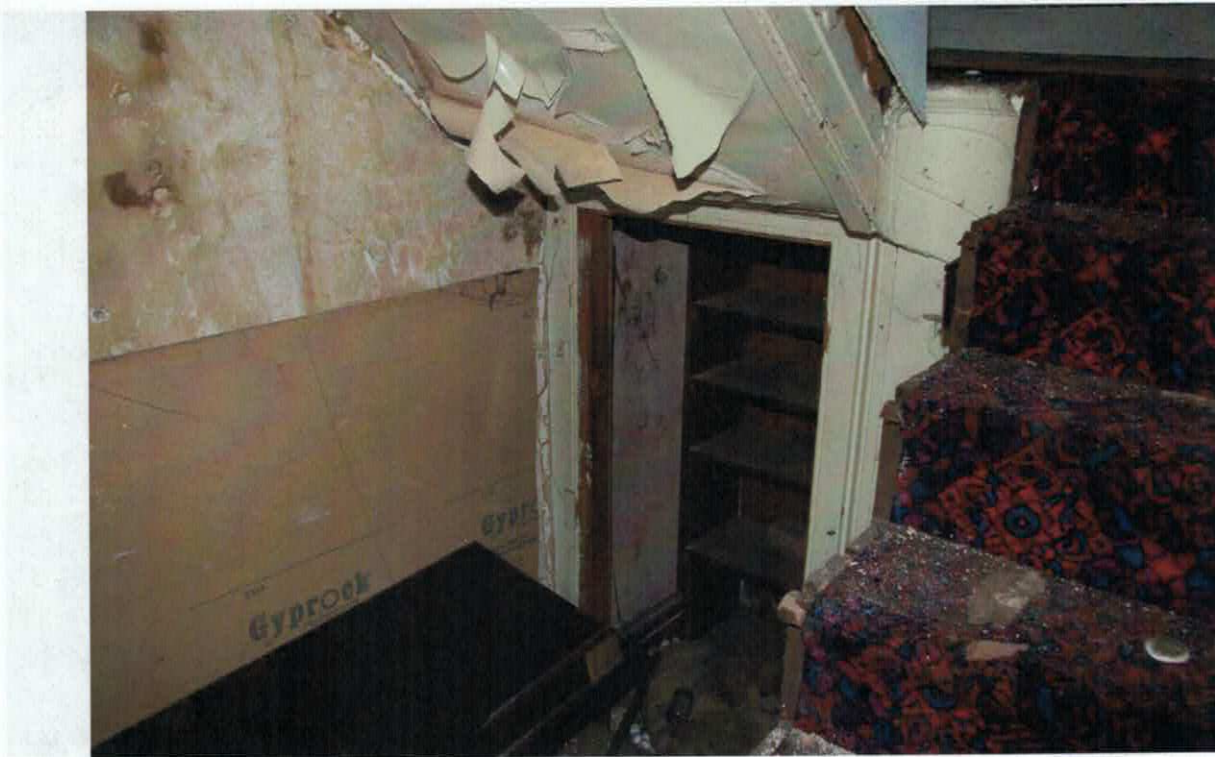
Figure 11 The central stair at ground level with missing balustrade.

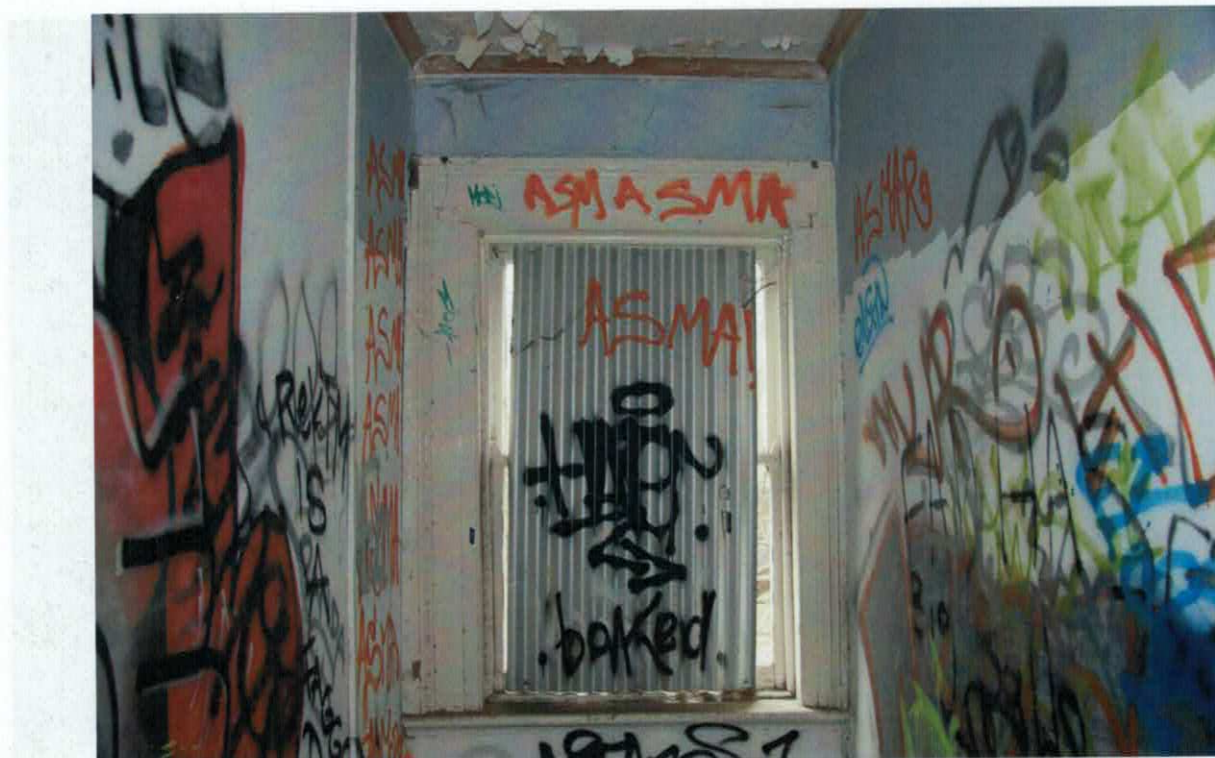
Figure 12 The first floor corridor window.

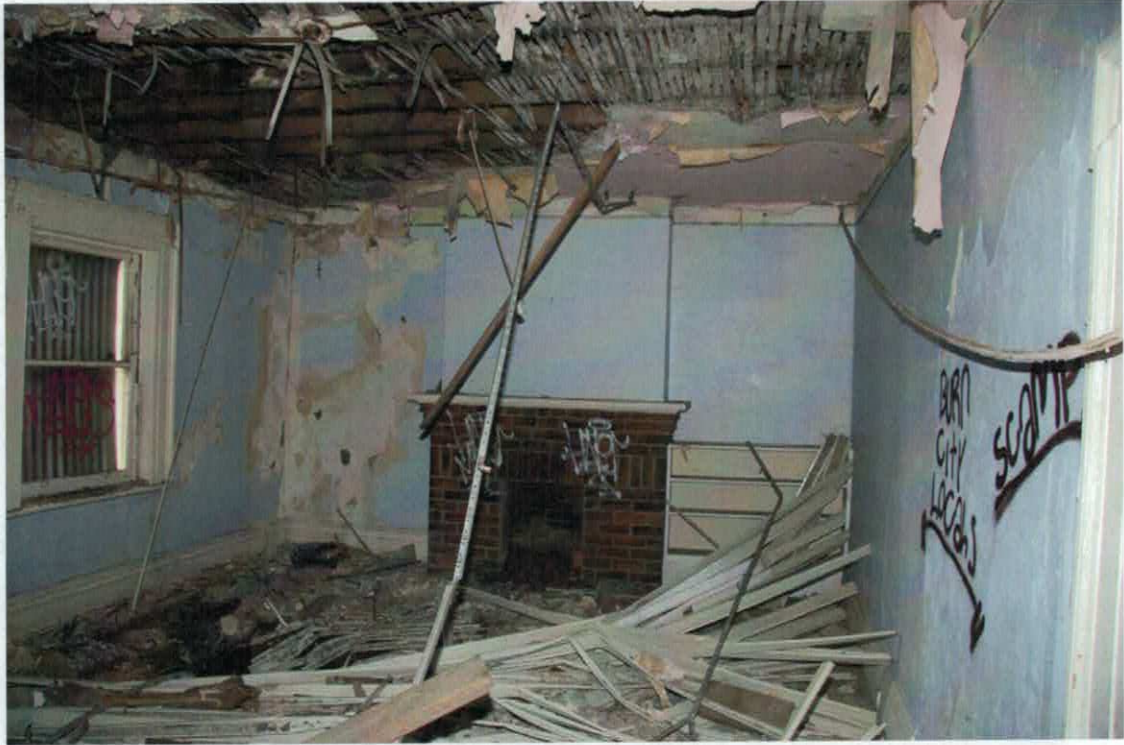
Figure 13 The main 'sitting room' on the first floor. Both the ceiling and floor are in a state of collapse.

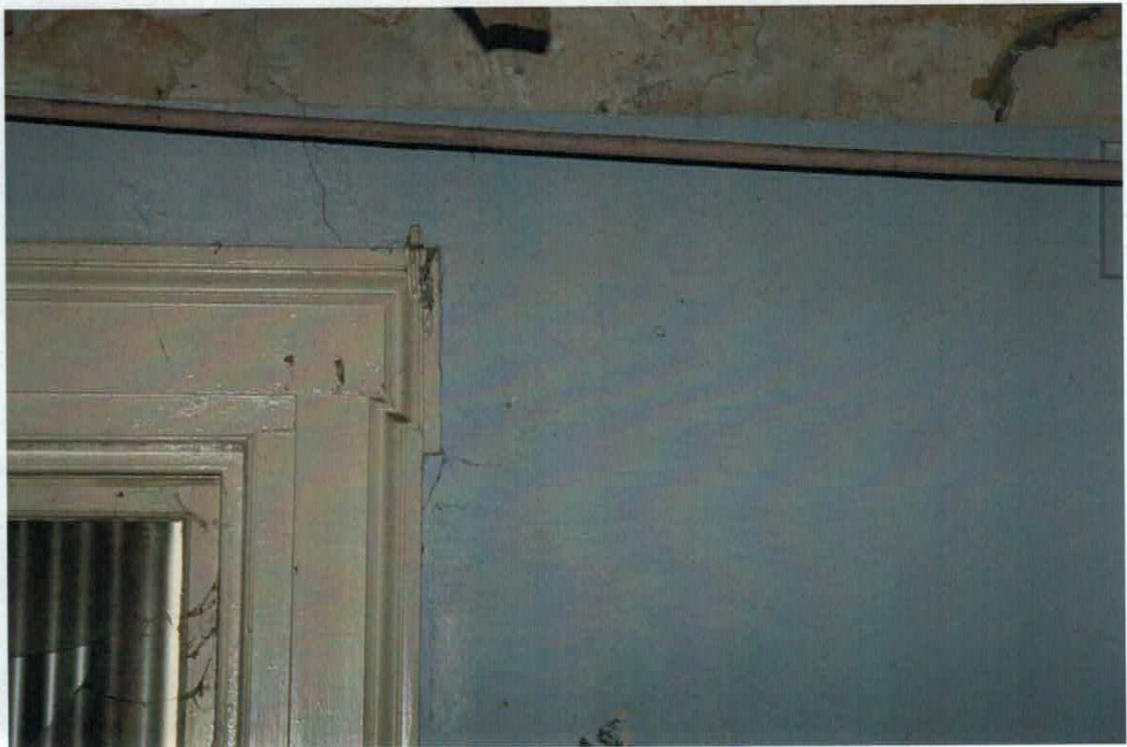
Figure 14 The architrave detail on the first floor

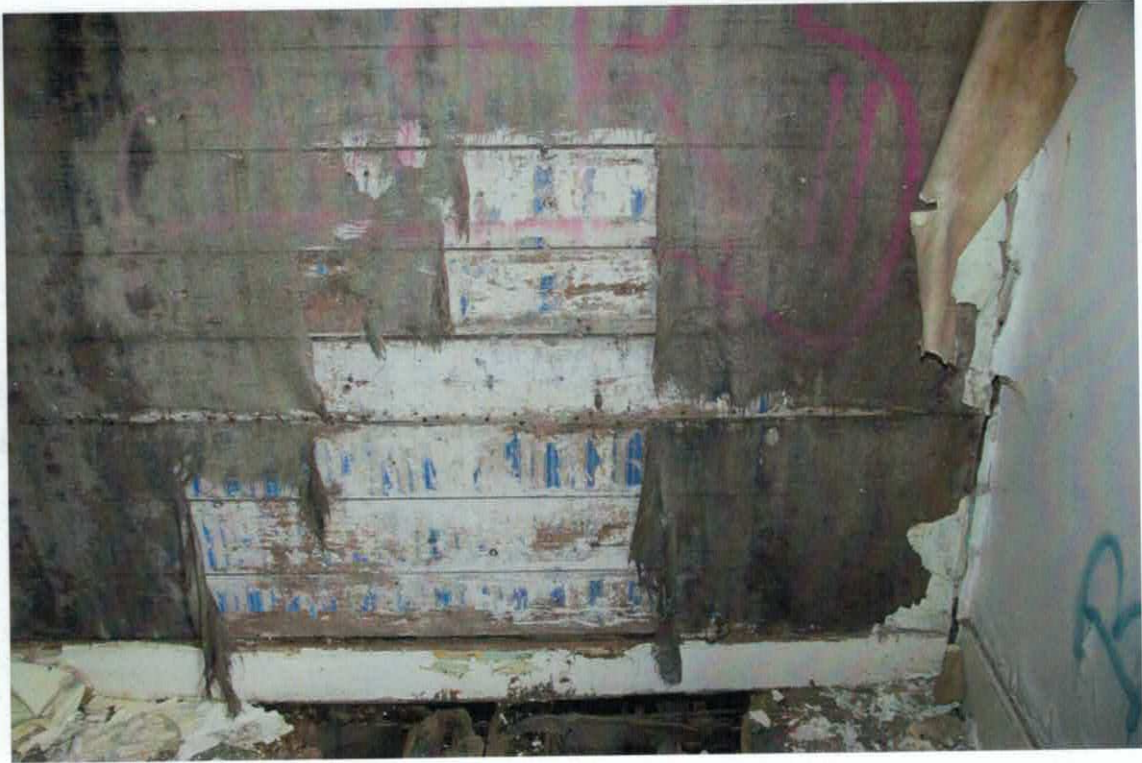
Figure 15 Detail of later timber framed partition wall on the second floor.

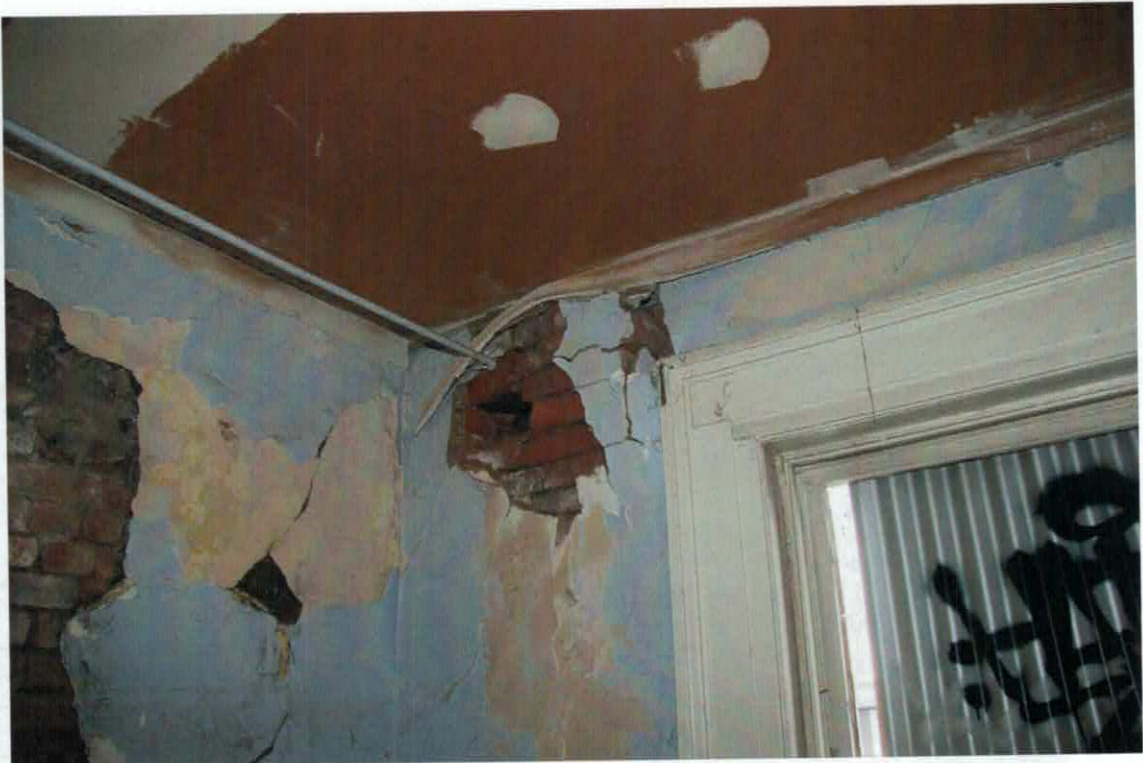
Figure 16 The typical architrave detail to doors and windows. Note the bulging bricks caused by wall movement.

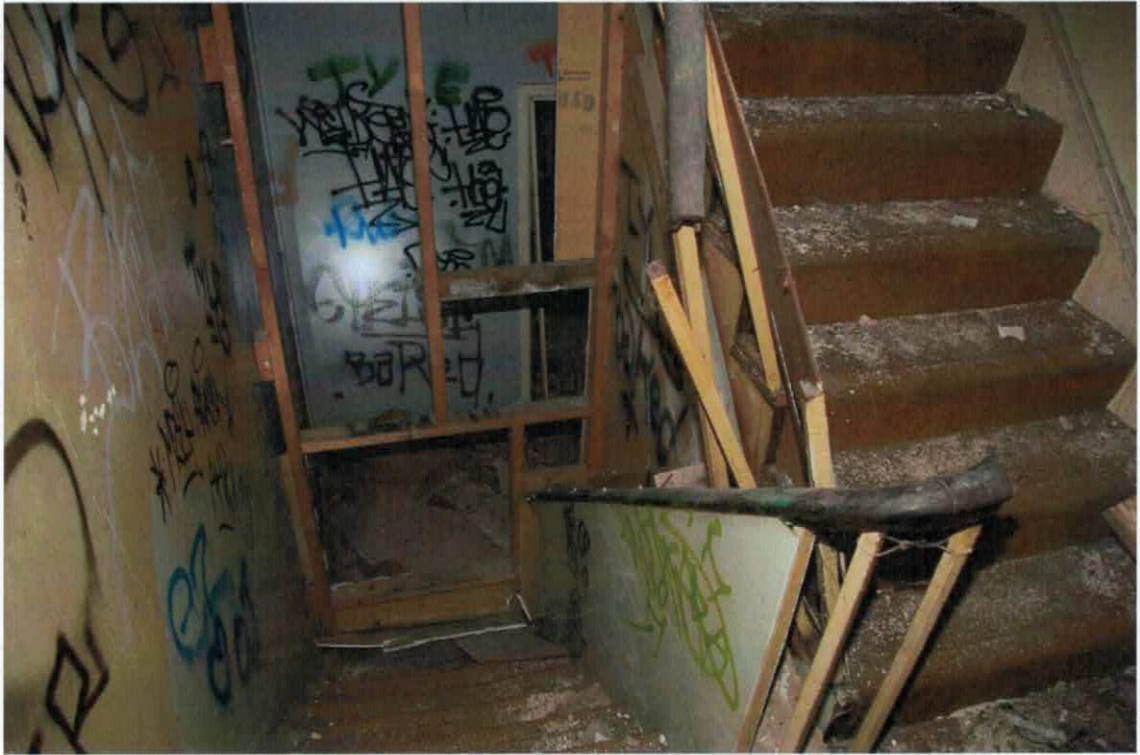
Figure 17 The stair between the first and second floors

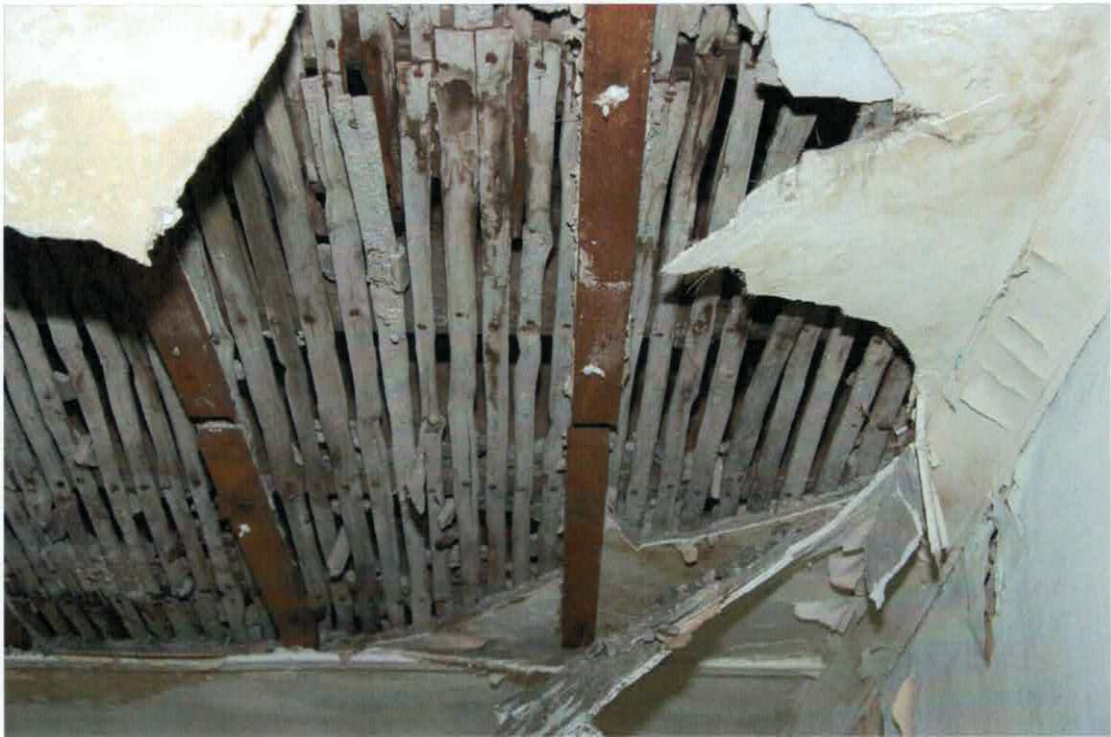
Figure 18 Split hardwood laths used in a ceiling. These are typical for the date of construction.

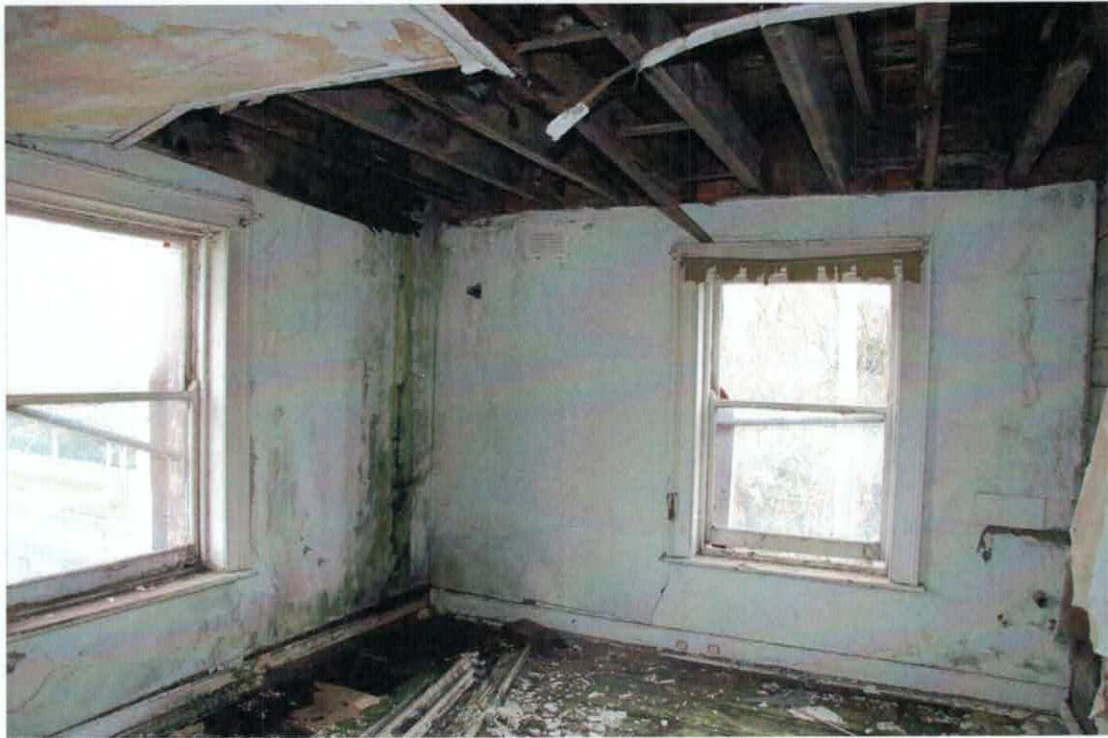
Figure 19 The second floor corner room

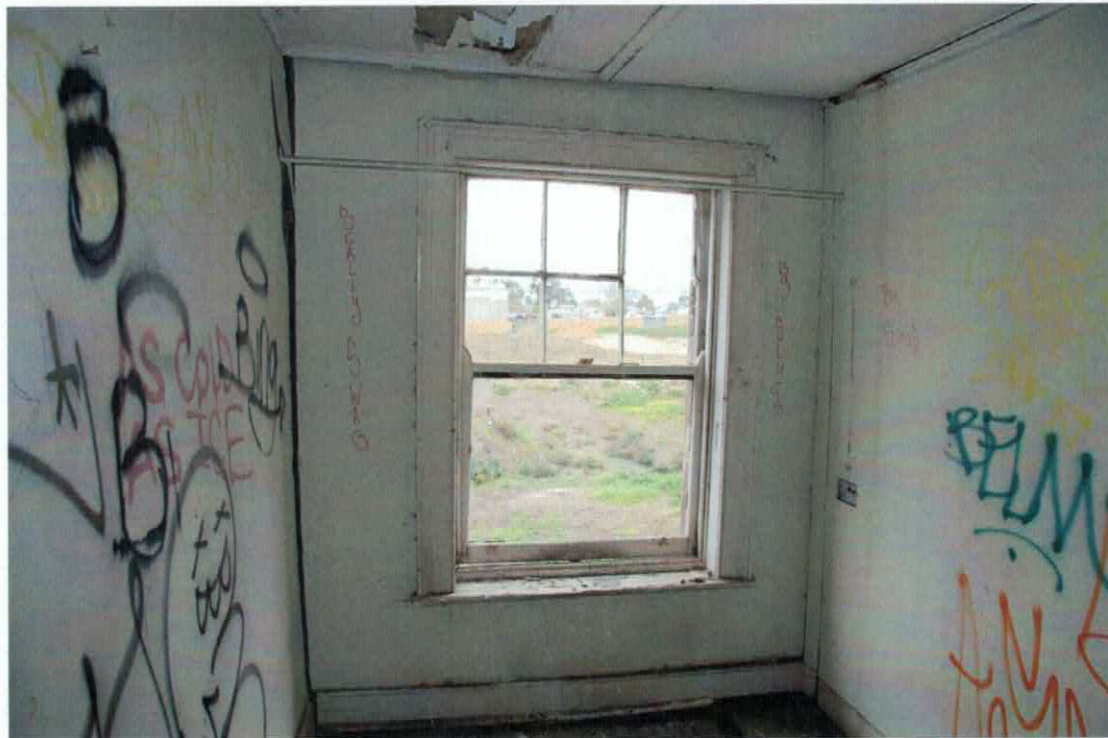
Figure 20 A single bedroom on the second floor showing the one surviving 6 pane window sash

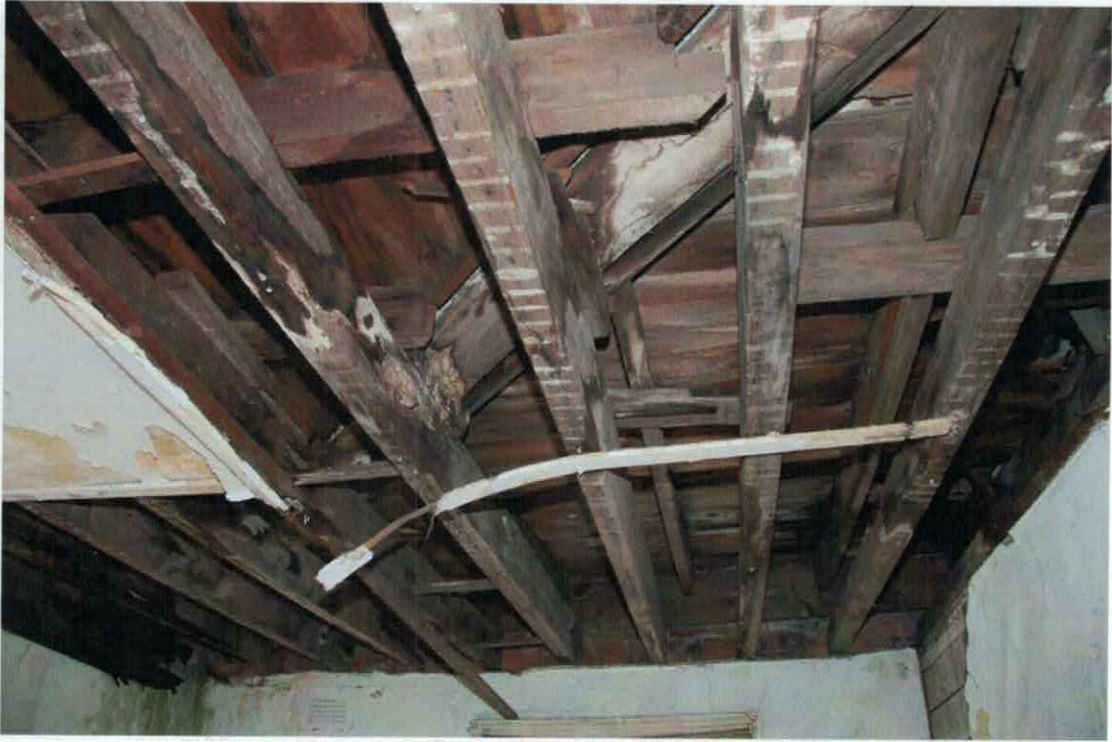
Figure 21 The underside of the roof framing showing the structure supporting the earlier flat roof.

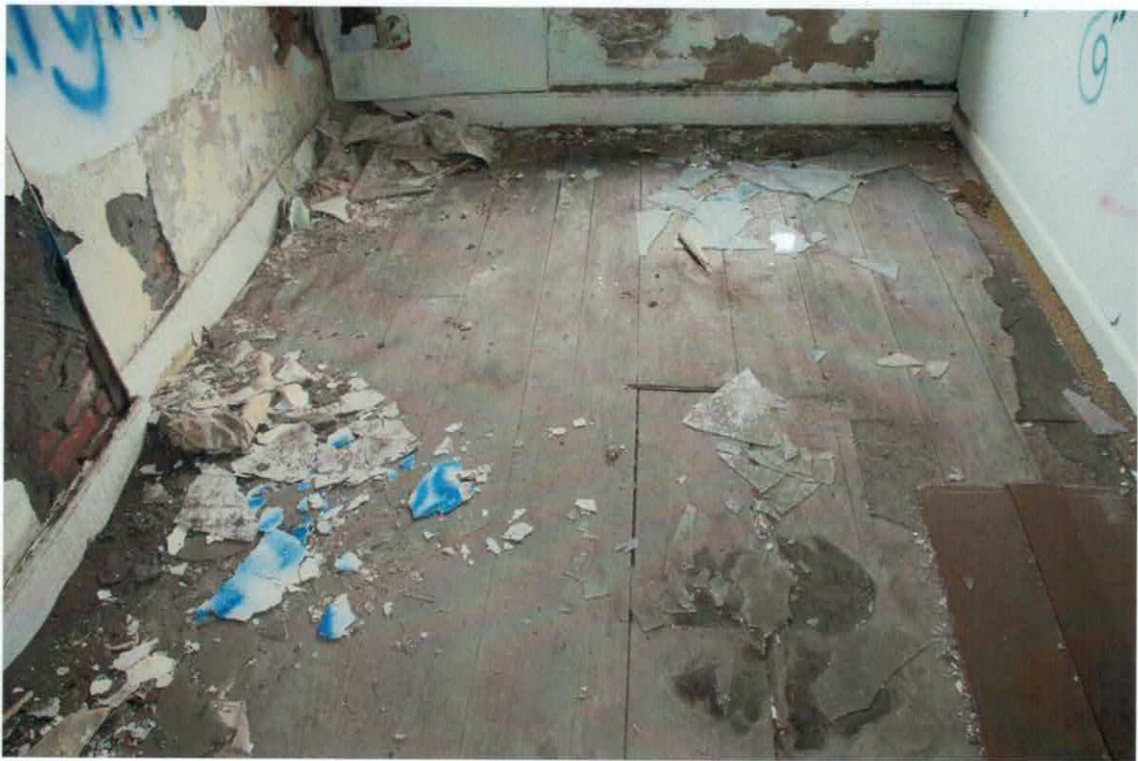
Figure 22 A typical floor showing varying board widths. The boards are tongue and groove jointed.

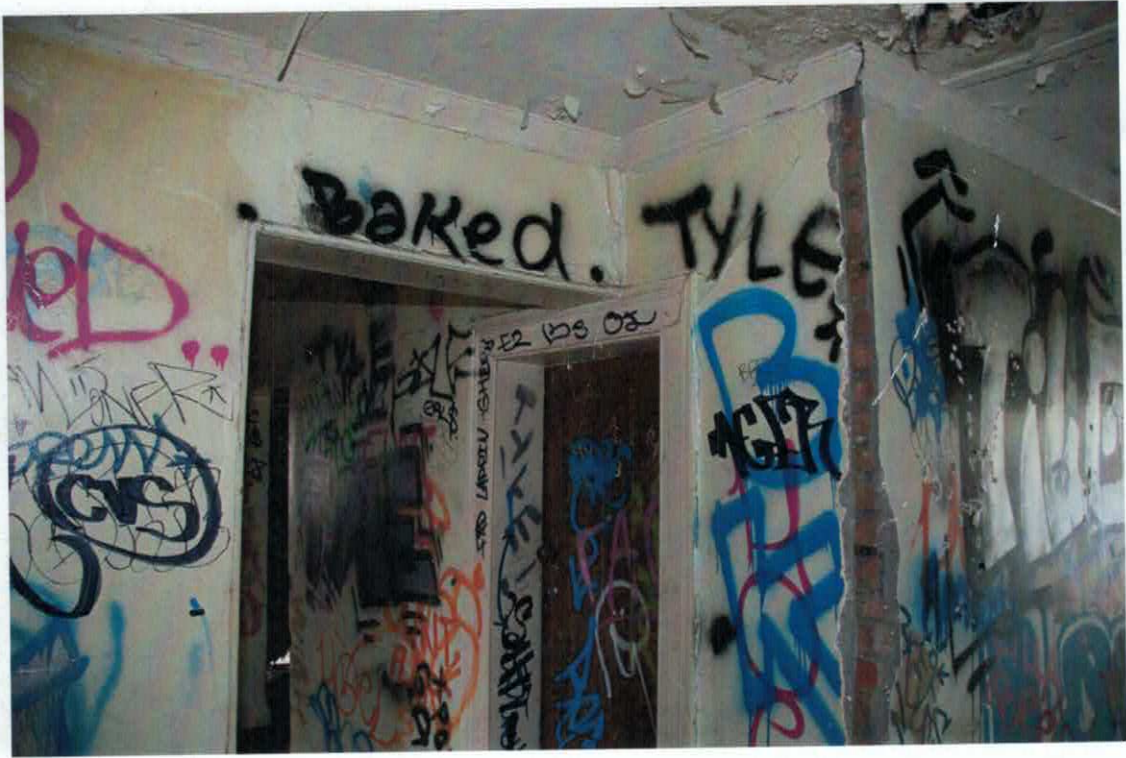
Figure 23 Door wall detail on the second floor.
